Hatteras Breach, North Carolina

by Ty V. Wamsley, Kent K. Hathaway, and Michael Wutkowski

PURPOSE: This Coastal and Hydraulics Engineering Technical Note (CHETN) is intended to document the rapid response of the U.S. Army Corps of Engineers to engineer and construct a breach closure and the lessons learned. The note also documents the short-term morphologic evolution and hydrodynamic characteristics of the breach based on an analysis of collected data. Researchers are utilizing this important data set in the development of numerical models of coastal breaching and to further the Corps' understanding of the breaching process.

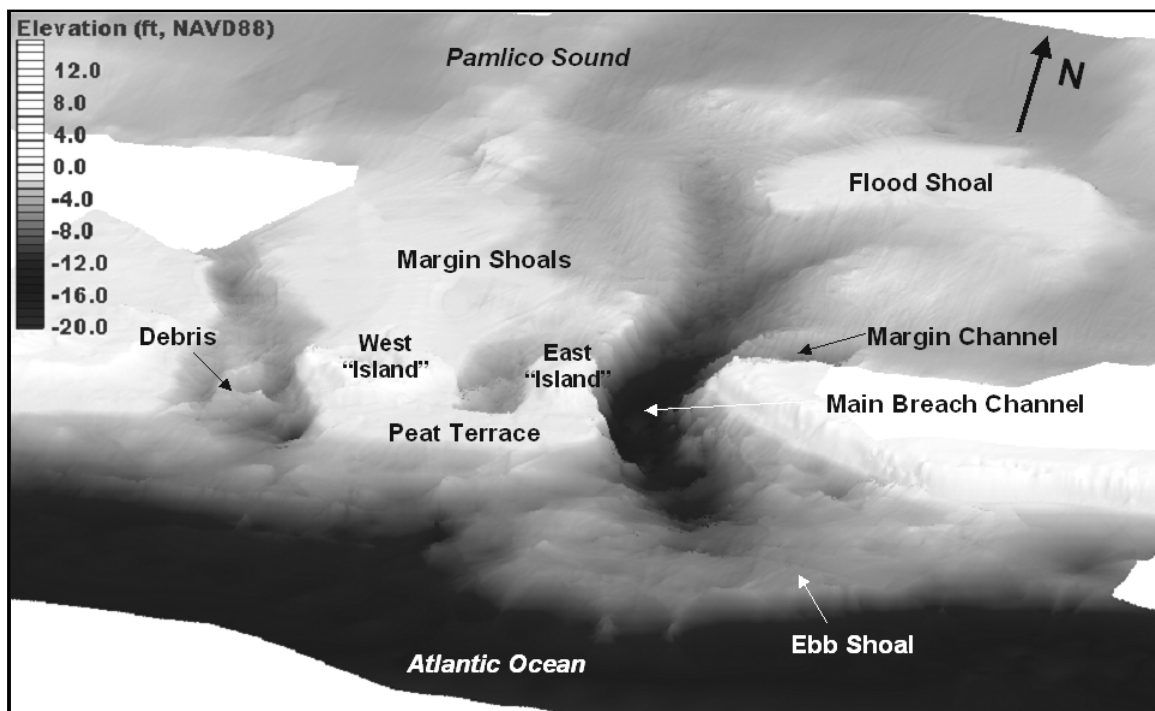
Figure 5. Digital elevation model of Hatteras Breach.

The flood shoal is readily identifiable in Figure 5. The Survey 1 DEM showed that a flood shoal formed within 2 weeks after the breach opened with the centroid approximately 1,750 ft from NC12. The shallowest water over the flood shoal was less than 0.5 ft NAVD88 and had to be surveyed by wading, as depths were too small even for the waverunner system. The second survey showed little growth of the flood shoal. A volumetric analysis indicates that the flood shoal gained on the order of 10,000 cu yd of sand over the 10-day period. A well-defined ebb shoal also formed by 5 October (Figure 5). The ebb shoal extended offshore as far as 1,250 ft from the former location of the highway. Depths over the ebb shoal were 4 to 6 ft NAVD88. Waves were often observed breaking on the ebb shoal.

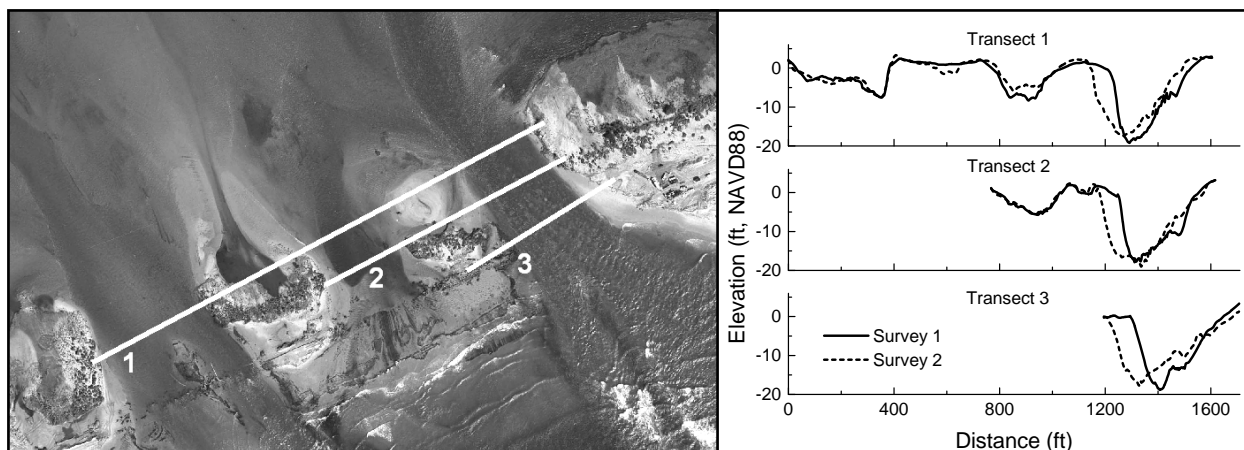
The DEM analysis indicates rapid morphology change. Figure 7 is a comparison plot of breach cross sections from Surveys 1 and 2. Comparisons are made only where sufficient coverage of the channel was captured by both surveys. Due to debris and wave conditions, the seaward end of the west breach channel was not measured in Survey 1. As Figure 7 shows, there was little change in the west channel, because of the substantial amount of armoring by debris and peat. Flow velocities were significantly weaker than observed in the main channel. The sound end of the middle channel shoaled approximately 2.5 ft in the 10 days between surveys. The sediment likely originated at the margin shoals on the sound side and could not be flushed out by flow restricted by the peat terrace. The central and seaward portions of the middle channel did not change between Surveys 1 and 2.

Figure 7. Comparison of Survey 1 and Survey 2 breach channel cross-sections (NCDOT photograph).

The main breach channel experienced the greatest amount of change. Defining breach width as the distance across the channel between the NAVD88 0-contour (which corresponds to +0.44 ft mean sea level), the breach widened by approximately 125 ft on the ocean side, 65 ft through the middle part of the channel, and 25 ft on the sound side. From the center of the barrier toward the sound, the main channel migrated approximately 20 ft to the west over the 10-day period while on the ocean side the channel migrated over 80 ft to the west. The average channel depths were maintained and maximum channel depths generally increased through the middle part of the channel and decreased on the sound side over the 10-day period. The average cross-sectional area of the breach channel increased from 3,400 to 4,000 sq ft.

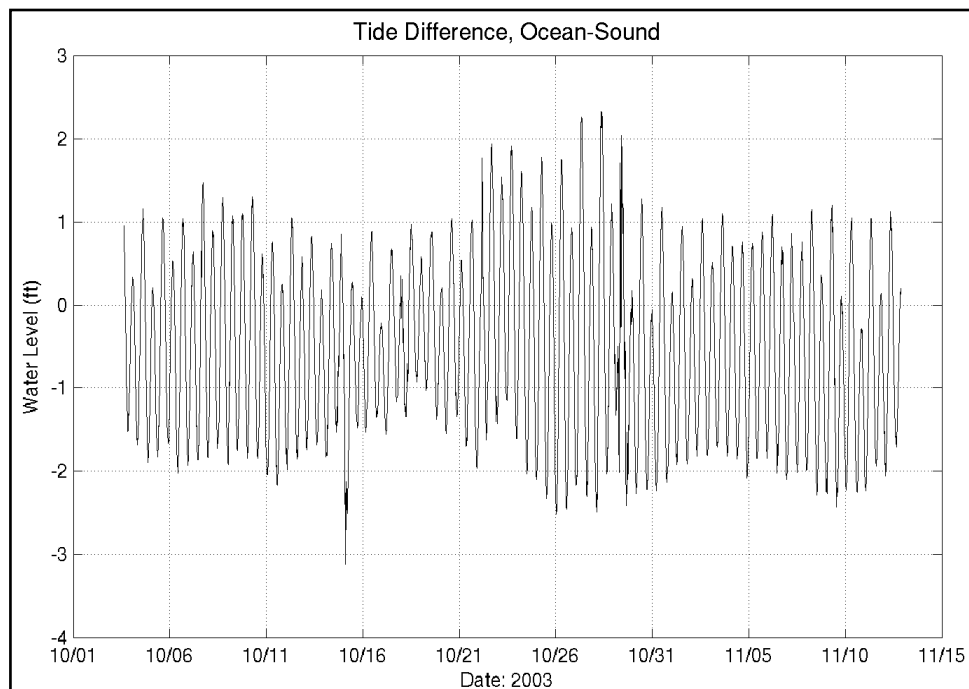
The measured water level (head) difference between the ocean and sound are plotted in Figure 9. Water level head differences exceeding 2.3 ft were observed on both flood and ebb currents. Water levels for the pier, sound, and the head difference from 14-18 October are plotted in Figure 10 along with wind measurements from the Hatteras Weather Service (Mitchell Field, 2.5 miles east of the breach). Wind contributes to head difference, particularly in determining sound water levels. Pamlico Sound, having a large surface area and shallow water, can experience large wind-driven setup. On 15 October, the wind switched from having a west component to an easterly component, resulting in setup in the sound and a large negative head (ocean levels lower than the sound) of -3.1 ft. There was a gap in the wind data on 15 and 16 October, but based on measurements at the FRF (66 miles north of the breach), the wind continued to be directed toward the east and south, favorable for setup in the southeast corner of the Pamlico Sound near the breach. As a result, a nearly continuous ebb current flowed for approximately 32 hr.

Figure 9. Pamlico Sound and ocean water level difference, 3 October to 12 November 2003.

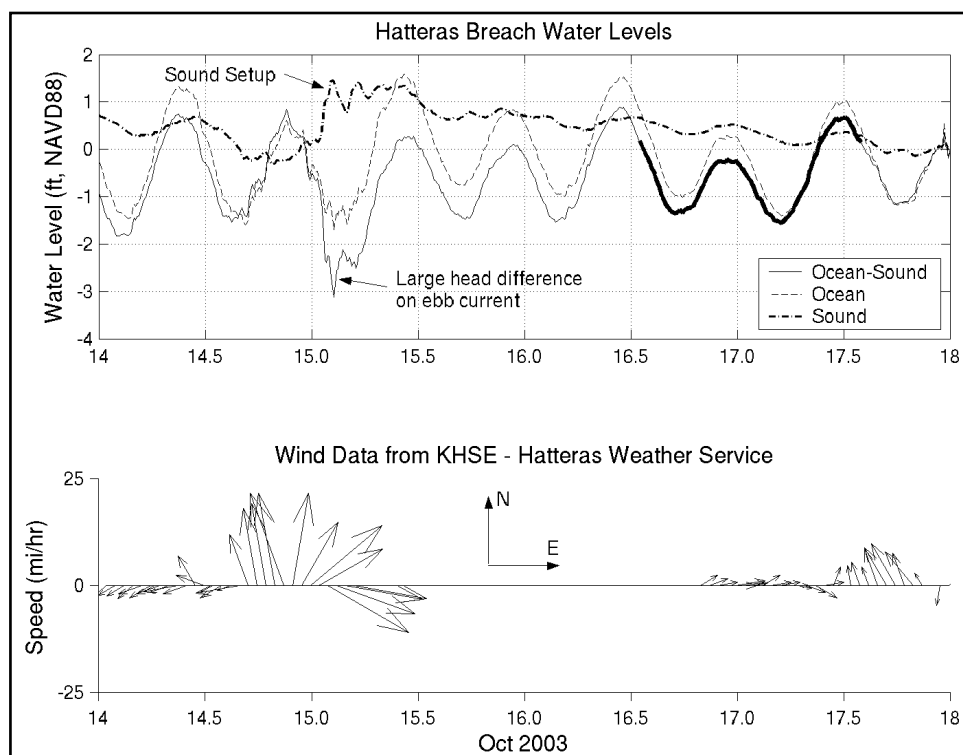
Figure 10. Ocean and sound water levels, head difference, and wind vectors.
Bold line indicated times when bottom mounted ADCP was operational.

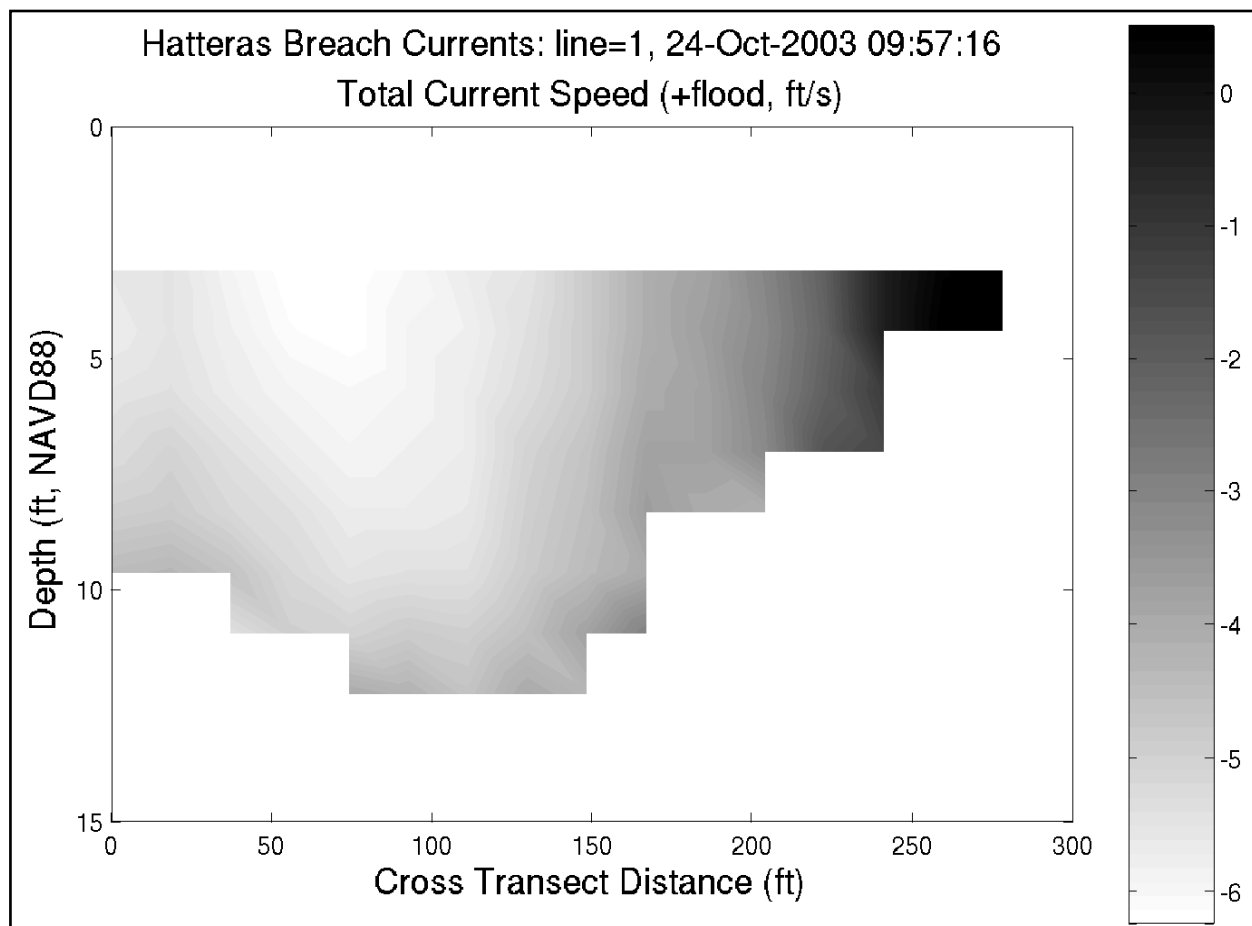
An example of an averaged ADCP ebb current transect is shown in Figure 12 for Line 1 on 16 October. Strongest currents are to the west (left) of the channel center. Ebb current transects for Line 2 indicate that the strongest currents tend towards the channel center. On Line 3, the strongest currents are observed to be east of the channel center and sometimes have two distinct maxima, one that parallels the main channel and another from the margin channel on the north-east side of the breach. This preliminary analysis of ADCP transect data corresponds to visual observations of surface currents, namely, that on ebb flow two distinct currents merged at the breach, and on flood flow there was a strong current through the main channel with a more diffuse current spread out over the area between the flood shoal and margin channel.

Figure 12. Example ADCP current transect at line 1.
